DYNAMIC TEST OF AN AIRCRAFT LITTER INSTALLATION

One of a Series of Reports Pertaining to the
Dynamic Crash Test of a U.S. Army H-21 Helicopter

March 1963

TRECOM Technical Report 63-3

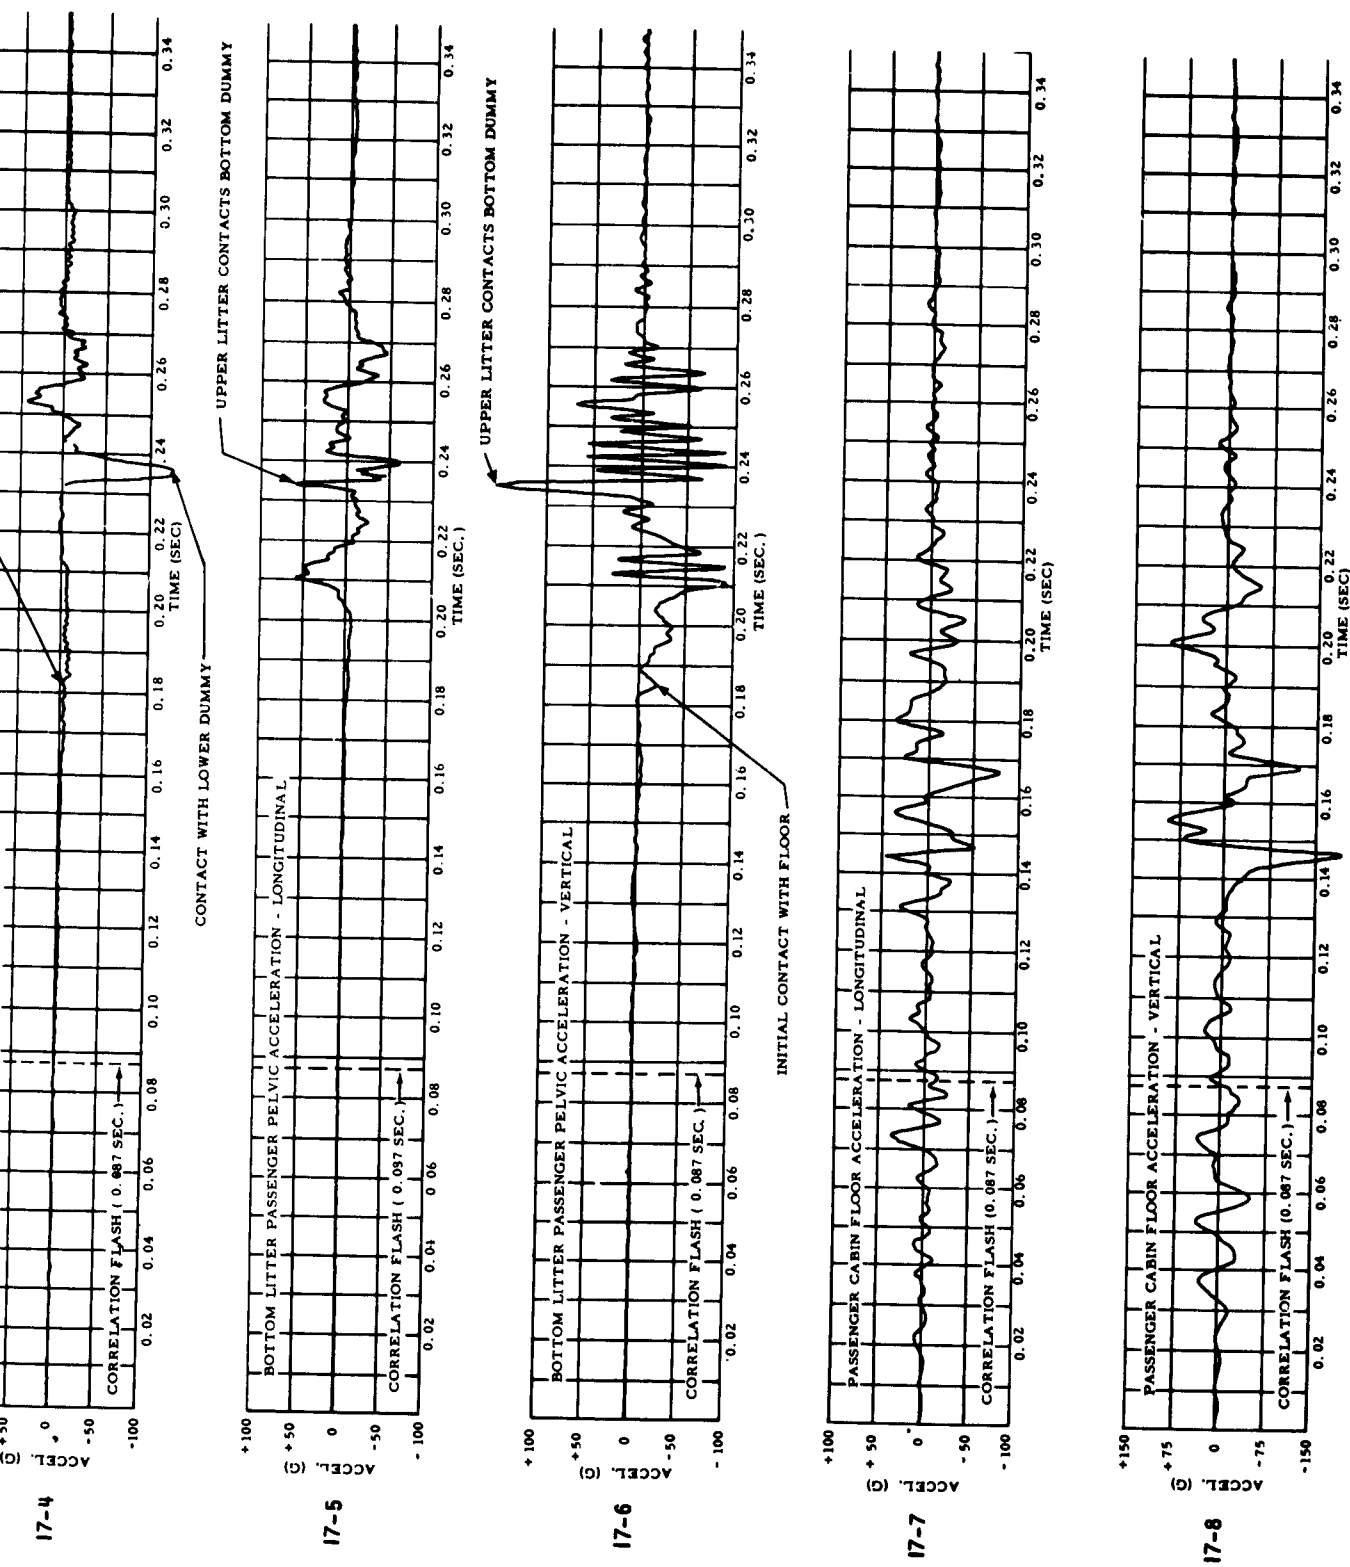
1. No appreciable deceleration (horizontal or vertical) was imposed upon either dummy from the time of impact of the nose gear of the H-21 (time zero) to about 0.19 second, at which time the bottom dummy contacted the floor due to deformation in both the airframe and in the litter support system. A 50G vertical acceleration of over 10 milliseconds duration was recorded in the pelvic region of the lower dummy following contact with the floor.

2. The maximum loads in the litter straps were recorded at approximately 900 pounds per strap. Assuming that the litter brackets supported an equal load, the total load would then be $4 \times 900 = 3,600$ pounds on the complete system. This load would produce 9G on the 400-pound mass of the two dummies. The vertical acceleration records (Figures 17-4 and 17-6) indicated accelerations of this order of magnitude up to contact of the lower dummy with the floor.

3. Both the upper and lower litters slipped out of the brackets attached to the rear support strap with subsequent reduction in load in the strap. The rear strap and its support system did not fail.

4. The forward litter strap reached a load of over 900 pounds at the time of separation of the rear litter handles from the rear strap. This load dropped to about 800 pounds at 0.21 second and then immediately dropped to zero as the support at the cabin ceiling failed.

5. The contact of the bottom dummy with the floor of the aircraft resulted in oscillatory "longitudinal" acceleration as measured in the pelvic region of the dummy. A positive (forward) longitudinal acceleration of 50G is seen to have occurred at 0.21

Figure 17. Accelerometer and Force Tensiometer Time-History Plots.

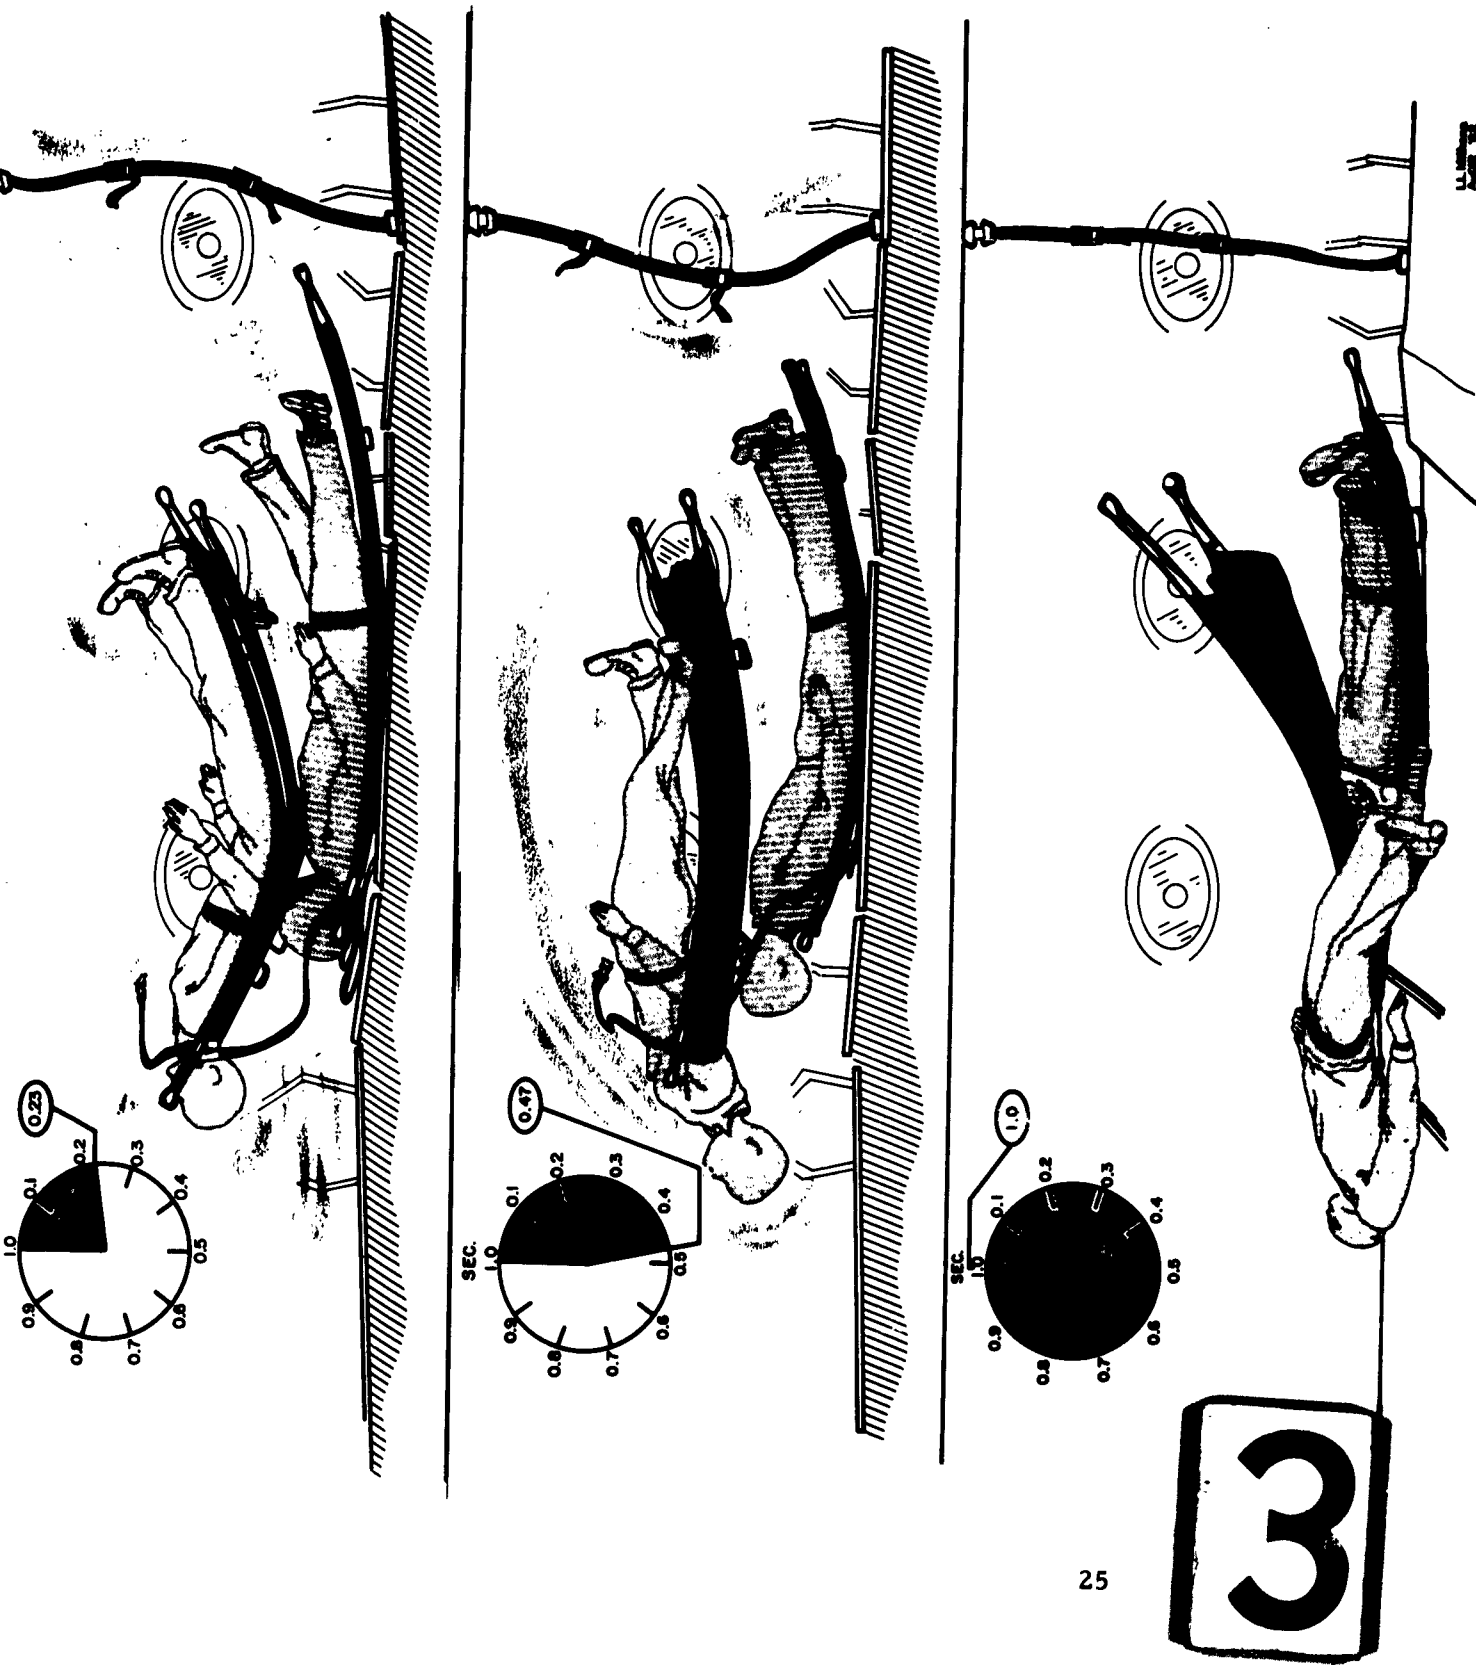
6. The top litter patient impacted the lower dummy at 0.23 second, as shown in Figure 18. A "vertical" acceleration of 125G (see Figure 17-4) and a simultaneous longitudinal acceleration of 70G (Figure 17-3) were recorded. A positive vertical acceleration of 150G (Figure 17-6) was also recorded in the lower dummy. A positive acceleration in this instance implies that downward load has been applied as was obviously the case here.

Figure 18. Kinematic Drawing of Litter Restraint System During the Crash Impact Sequence.
